REVIEW ARTICLE

The Value of Snuffbox Tenderness: A Sign of Things to Come

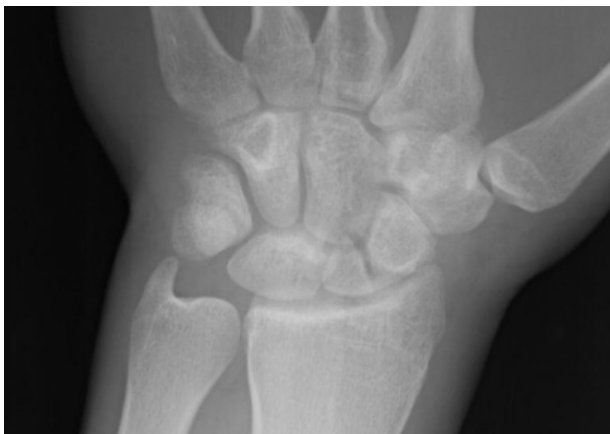
FIGURE 3:

Plain film radiographs - evidence fracture left scaphoid

and a technetium-99 scan was ordered (*Figure 2*). The technetium scan read positive for evidence of bone pathology in the left wrist, and at this time was placed in a short arm cast and instructed to follow up in four weeks. On return visit, he reported no improvement of symptoms and was subsequently referred to an orthopedic surgeon. At the initial visit with the surgeon, plain film radiographs of the left wrist were ordered and showed evidence of fracture of the left scaphoid (*Figure 3*).

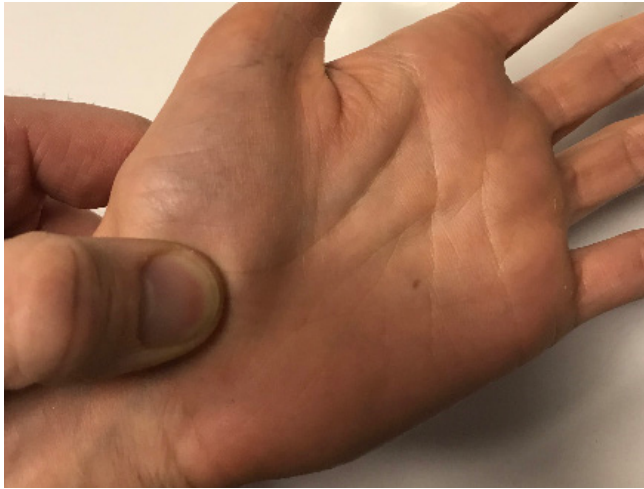
FIGURE 7:

Scaphoid tubercle tenderness

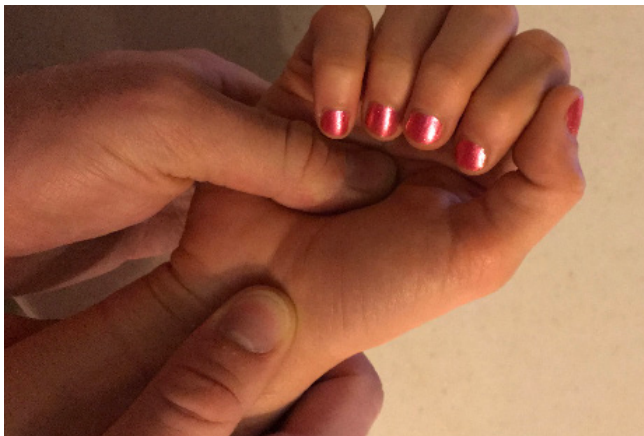
**FIGURE 8:**

Watson shift test

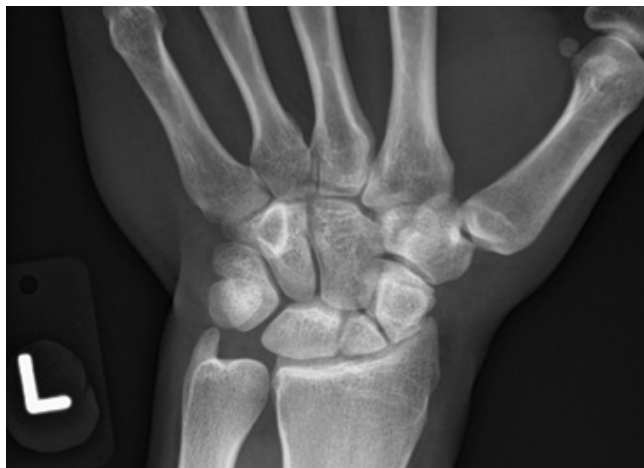
FIGURE 9:

Plain film radiograph that shows a chronic scaphoid nonunion with slight sclerosis of radial-carpal interface

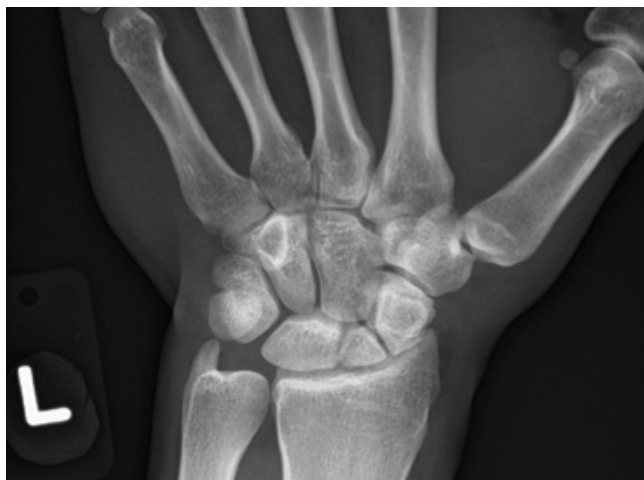
FIGURE 10:

Plain film radiographs showing two scaphoid fragments appearing nondisplaced

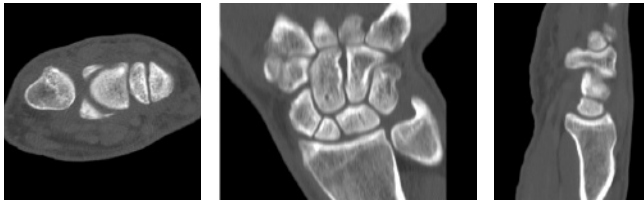
FIGURE 11:

CT scan showing the scaphoid fragments in good alignment

The patient is now 30-years-old and after being released from care with no restrictions approximately eight years ago, the patient began to ease back into his normal activities, which included returning to work in a tool and die shop, lifting weights, and racing motocross. He stopped racing motocross another year later but has continued to lift daily. He is currently asymptomatic other than some slight discomfort while lifting weights, but only with certain movements or grips. Despite being relatively asymptomatic, he chose to establish a relationship with a new hand and wrist specialist for a checkup and long-term management. During the visit with the hand and wrist specialist, plain film radiographs were taken that show a chronic scaphoid nonunion with slight sclerosis of radial-carpal interface, but the two scaphoid fragments appear to be nondisplaced (*Figure 9,10*). A CT scan was also ordered which shows the scaphoid fragments to be in good alignment with less than 1mm gap between the

two fragments, less than 1mm of shifting, and no signs of avascular necrosis (*Figure 11*).
